Accident Reference: 13-2010

Air Accident Investigation Interim Report

Boeing 747-44AF
N571UP
Dubai
United Arab Emirates
September 03 2010

General Civil Aviation Authority of the
United Arab Emirates

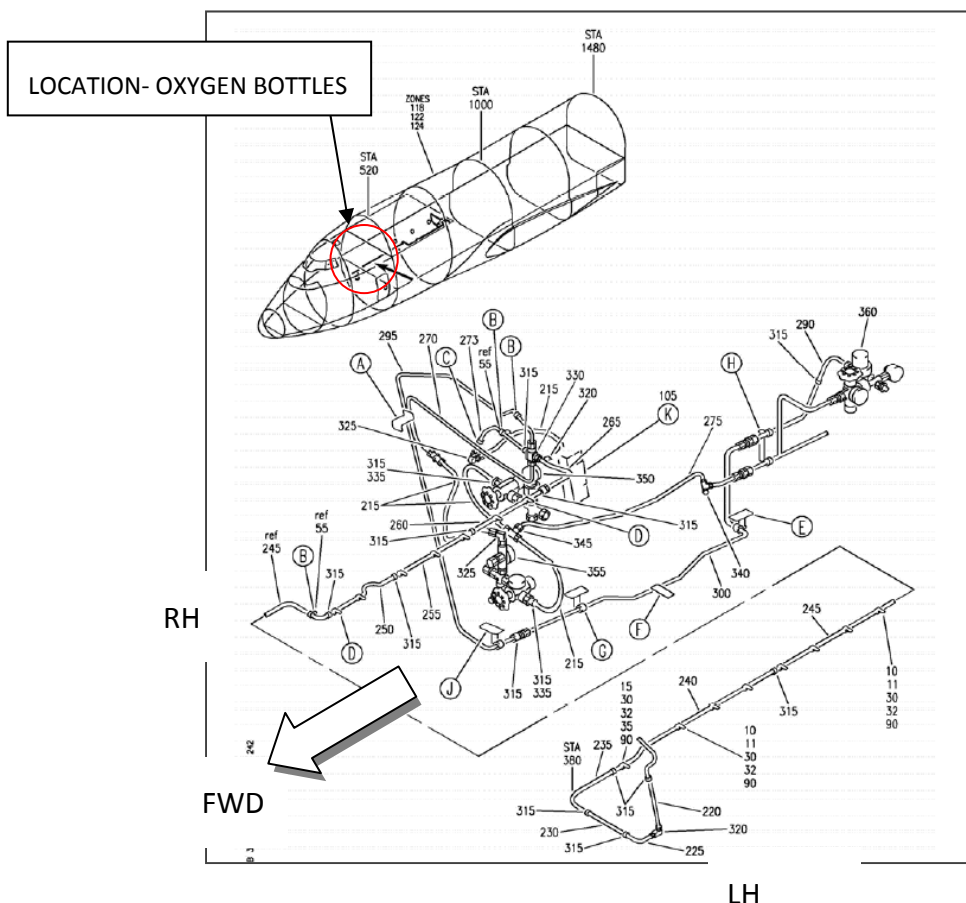
FIG 3: CREW OXYGEN TUBING ROUTING AFT OF STN380 BEFORE THE SECOND STAGE REGULATOR.
 [Crew Oxygen Tubing Routing Tubing material specifications: 0.3125 in. OD x .020 in. LG 21-6-9 CRES Tube (Stainless steel)]

The investigation is continuing to assess the potential for elevated oxygen supply temperatures in the oxygen supply system in the event of an uncontained fire in the immediate vicinity of the oxygen tubing routing CRES Tube.

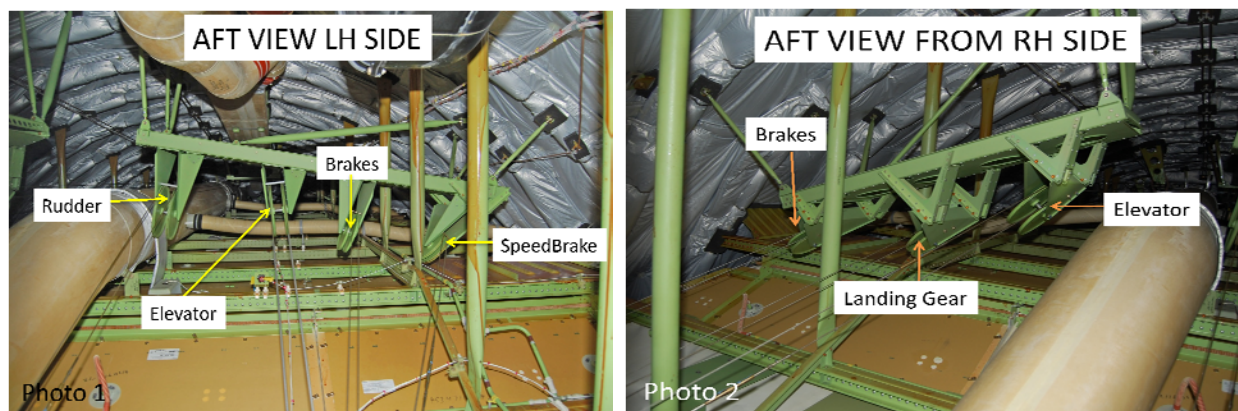
Photo 1 & 2 – Flight Control Locations

The flight control cables, pulleys and support trusses at the location of the main deck transition ceiling panel, located above the probable fire zone.

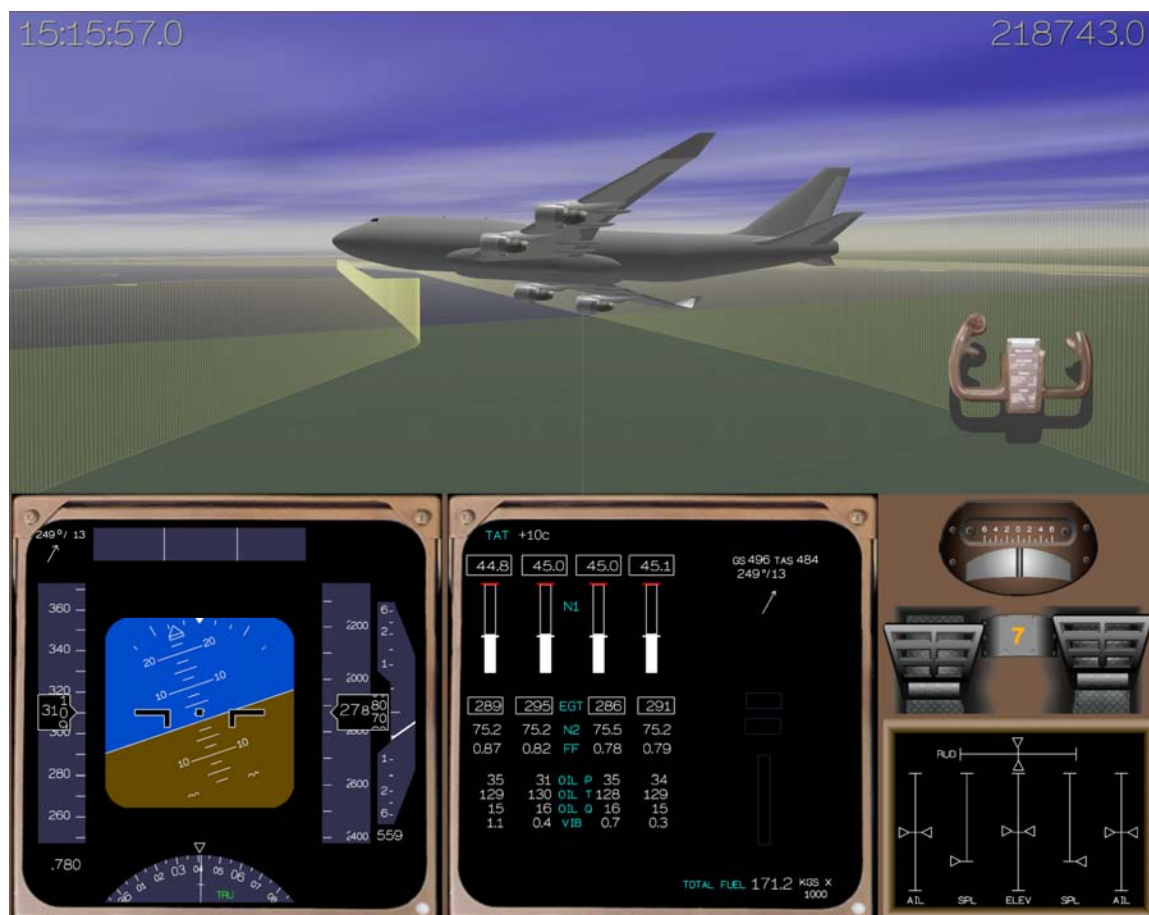
FIGURE 8 - 15:15:57 UTC - IN-FLIGHT TURN BACK – PITCH CONTROL

- Column deflection moves to full nose-down deflection. The elevator deflection is not consistent with the nose-down deflection recorded for the column deflection parameter.
- FDR elevator data show little to no deflection while there are large deflections in column position. The flight path of the airplane, following the fire indications, is consistent with the elevator deflections.

15:16:42 CAPT - Comment about no control
15:16:47 CAPT - Comment about no pitch control
15:16:57 - *Fire Zone 2 Aft Cargo (lower deck)*
15:17:05 - *Fire Zone 3 Aft Cargo (lower deck)*
15:17:19 (ATC) - Captain informed ATC that cockpit was full of smoke
15:17:39 CAPT - Comment about inability to see
15:17:44 - *AP On*

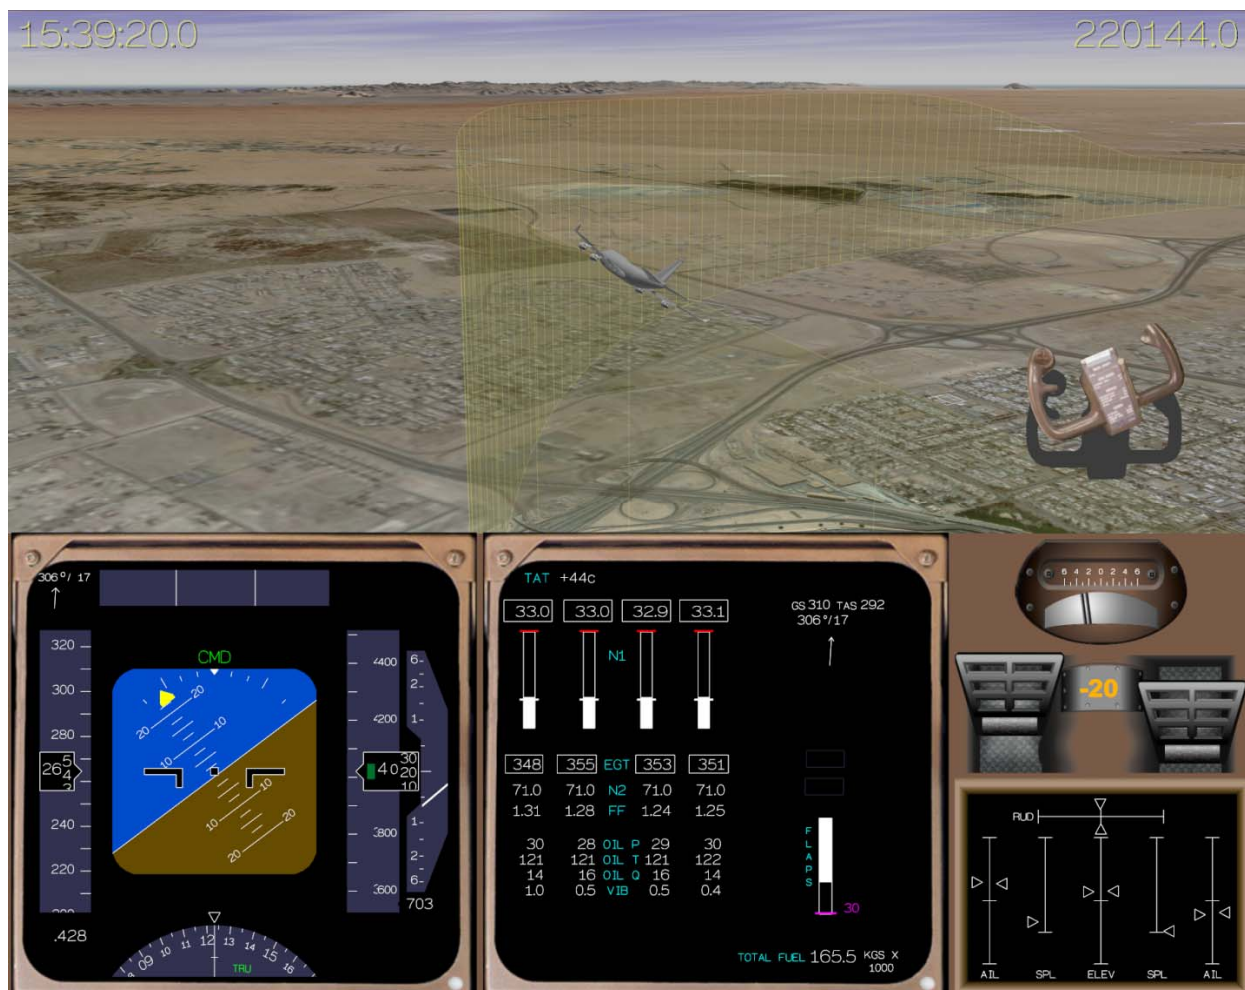
FIGURE 9 - 15:39:19 UTC - GPWS: BANK ANGLE WARNING

- The airplane rolls rapidly to acquire the new selected heading, reaching a max right bank angle of 37.5 degrees, see below

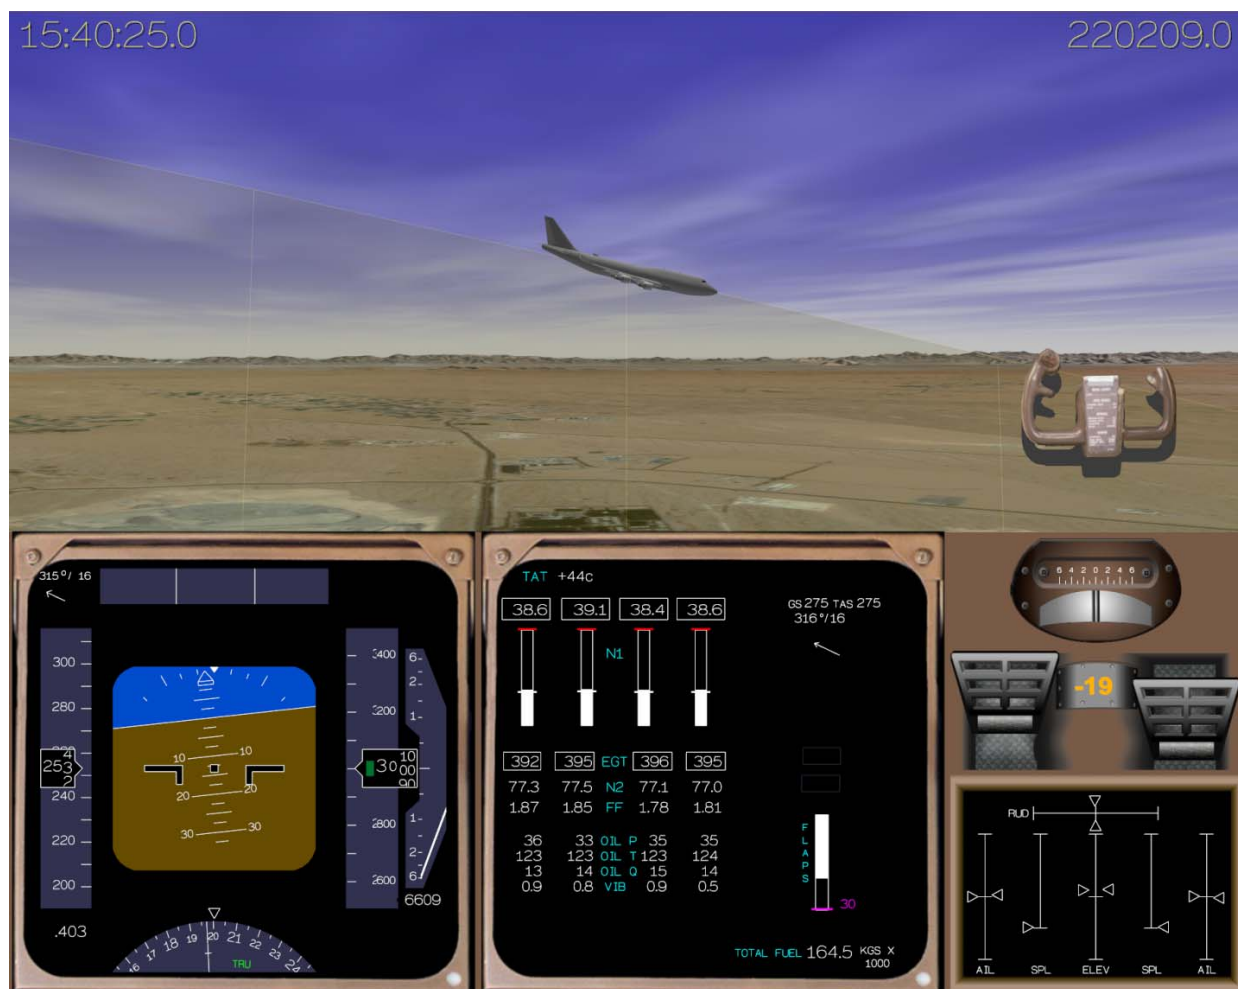
FIGURE 10 - 15:40:25 UTC – GPWS/'SINK RATE'

- Following the disengagement of the AP, the airplane pitched down to -14 degrees and began to descend. The transducer measuring the Captains column force and column deflection display rapid nose-up pitch commands during the final 40 seconds. Elevators moved with the nose-up column inputs but the deflection was inconsistent with the relationship seen at the beginning of the flight.
- Airplane heading crossed through the target (195 deg.) and continues as there was no wheel input to return to wings level.

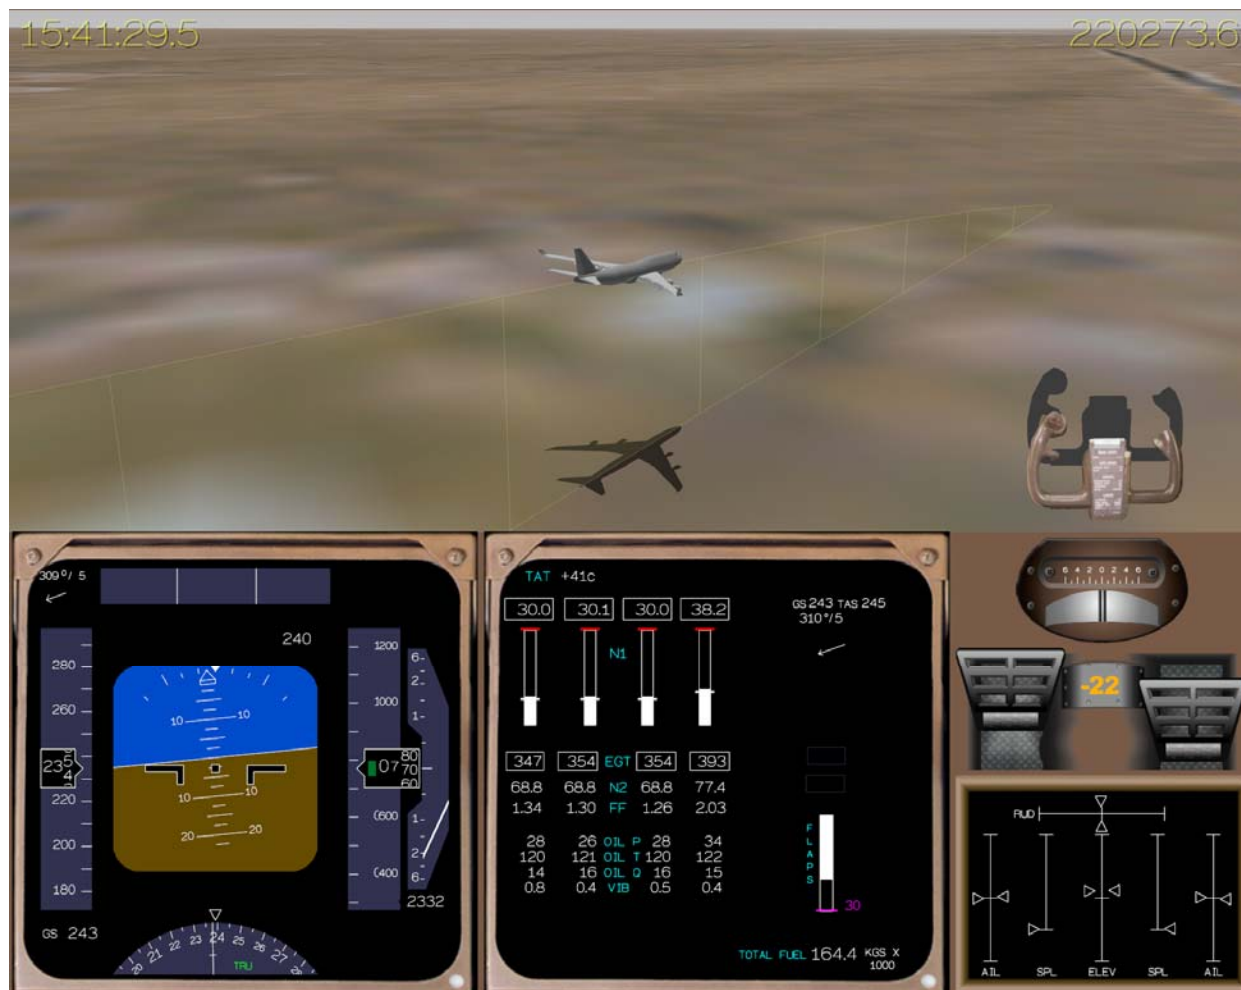
FIGURE 11 - 15:41:30 UTC - LOC-I/LOSS OF CONTROL/DATA ENDS

15:41:33 - GPWS - ‘Pull-Up’

15:41:34 - LOC-I: Loss of Control In-flight/Data Ends.

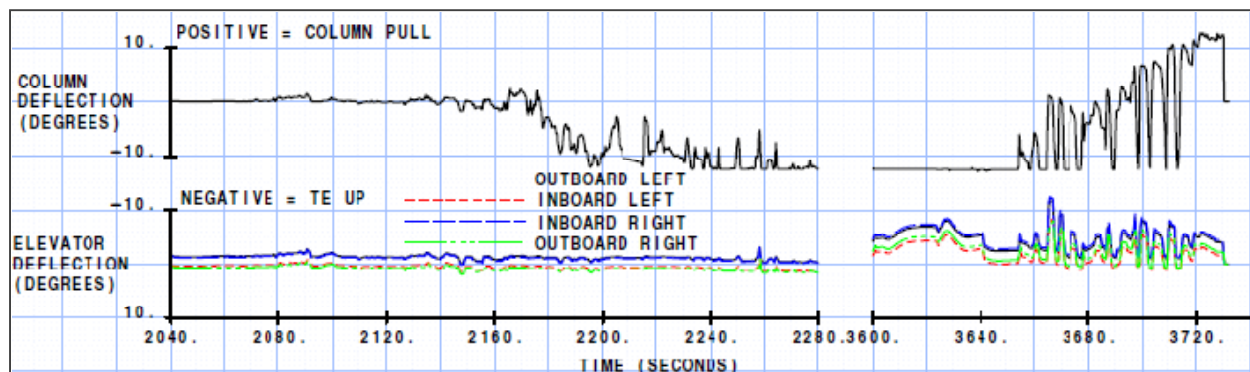
FIGURE 14 – COLUMN TO ELEVATOR DEFLECTIONS FOLLOWING THE INITIAL FIRE WARNINGS AND JUST PRIOR TO END OF DATA.

Near the end of the data, the FDR data shows nose-up column inputs (right plot Fig. 13 above).

The elevator was deflecting with the column inputs but not with the relative magnitude seen in Figure 13. This indicates that there was some column cable tension but not enough to maintain normal column to elevator gearing

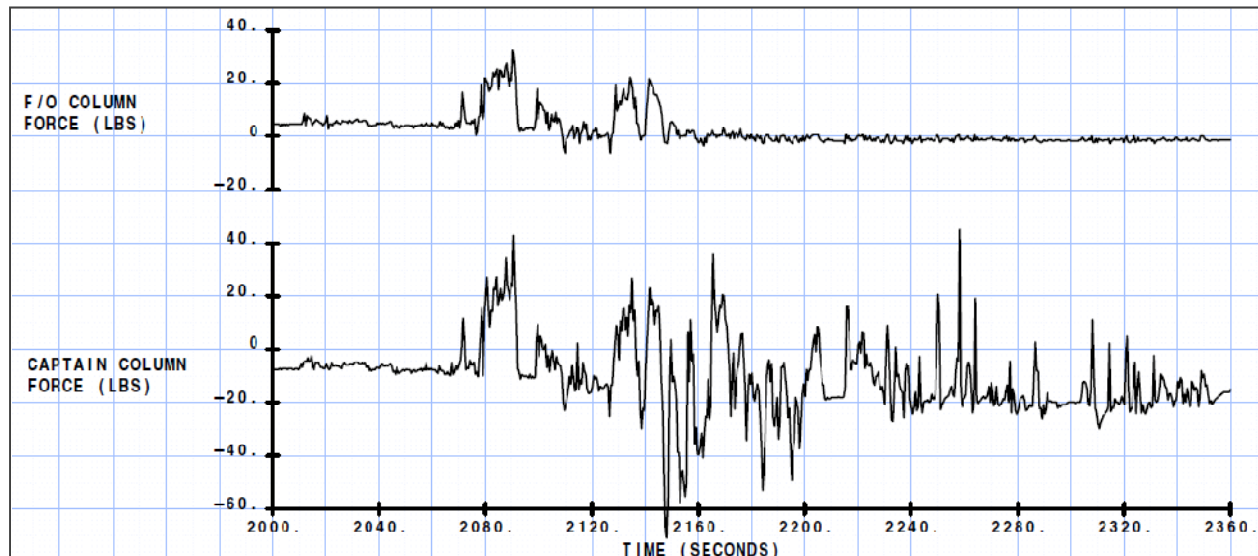
FIGURE 15: – CAPTAIN AND FIRST OFFICER COLUMN FORCES FOLLOWING THE FIRE WARNINGS

with zero cable tension, the force transducer on that quadrant will read zero. This effect is observed in the F/O column force parameter (Figure 15 below). The captain's column force parameter does not go to zero but it does require less force for the same change in column deflection. This is likely due to the fact that the captain's forward quadrant contains a tension regulator that was designed to remove slack from the elevator control cable. In effect the tension for the captain was less than normal but greater than zero while the tension for the F/O was effectively zero.

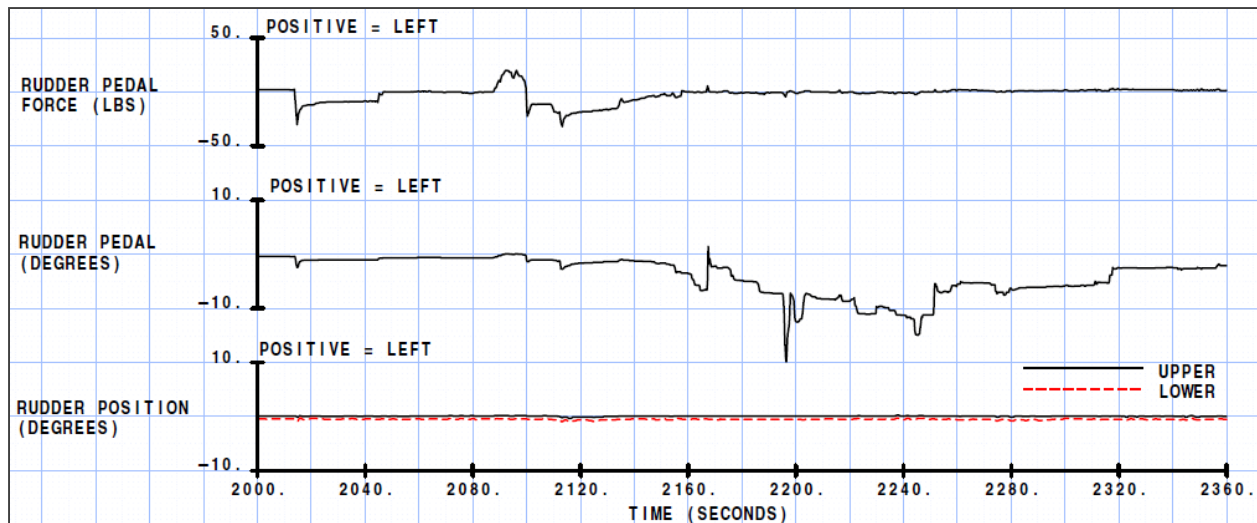
FIGURE 16: – RUDDER AND RUDDER PEDAL DATA

During the first segment the pedal force moves the pedal. For the rest of the time segment much larger changes in pedal are seen with no pedal force. In addition the 10 degree rudder pedal inputs are not deflecting the rudder. Both of these effects can be caused by a loss in tension of the rudder control cable.

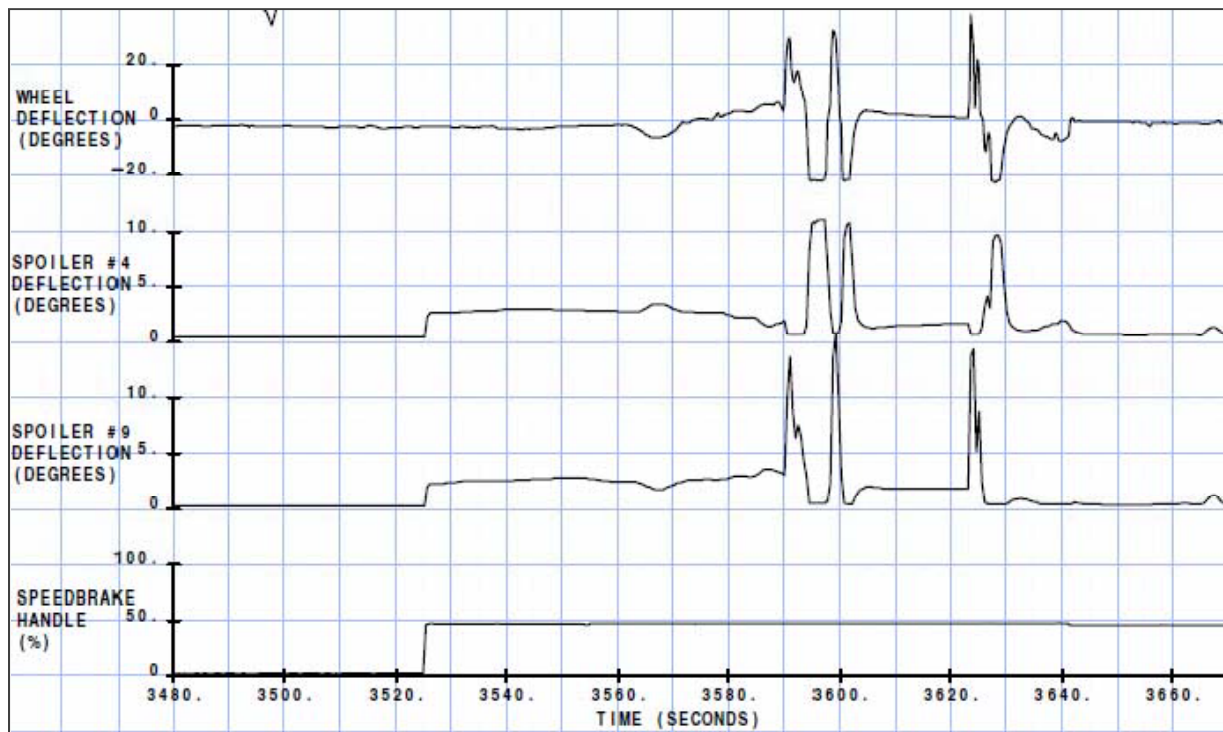
FIGURE 17: – SPOILER DEFLECTION FROM SPEED BRAKE HANDLE AND WHEEL DEFLECTION

Figure 17 (below) demonstrates the inconsistency between speed brake handle and spoiler deflection – At 15:38:09 to end of flight the spoiler response to speed brake handle when moved to flight detent position was only 3 to 4 surface degrees for flight spoilers #4 and #9 (Figure 18). Normal response to speed brake flight detent for these spoiler surfaces would be greater than 25 degrees at the flight conditions. The spoiler panels responded normally to wheel inputs during this time period which demonstrates that these spoiler surfaces had capability to move further. Spoiler deflections are consistent with the flight path of the airplane
